KING SALMON AIRPORT

2004 Alaska Airport Pavement Condition Report

KING SALMON AIRPORT - 2004

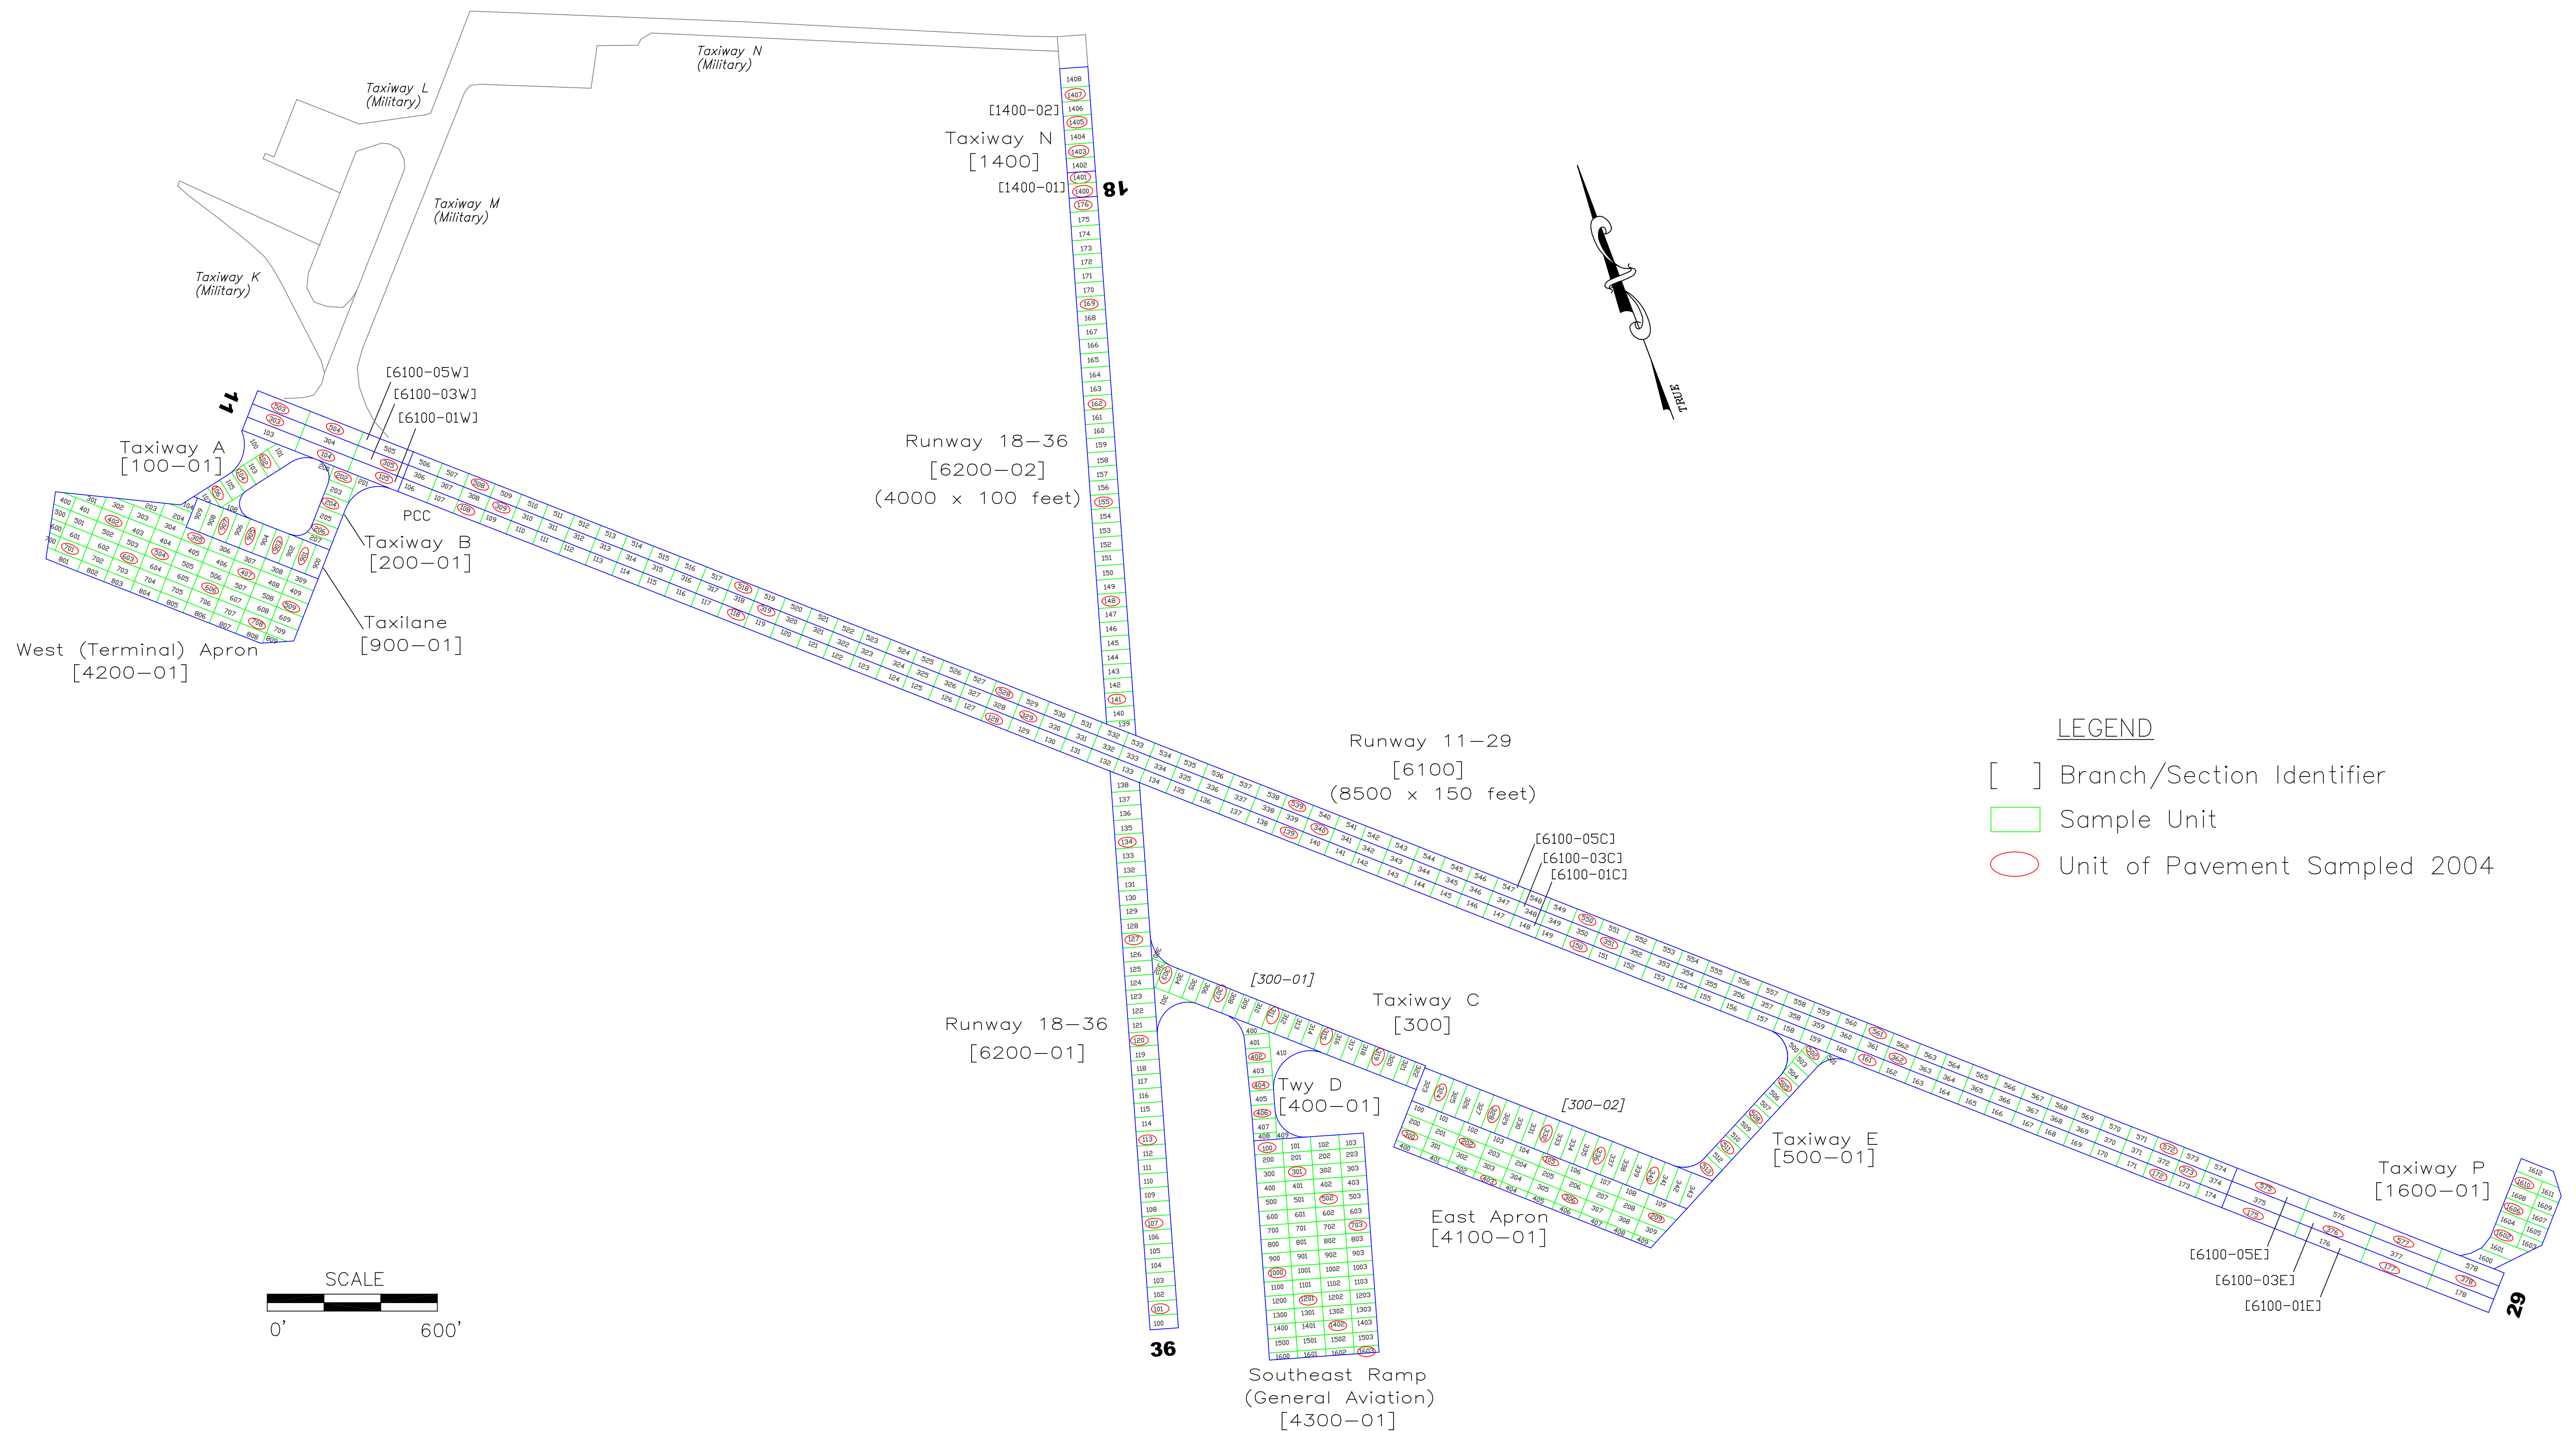
- [] Branch/Section Identifier
- Sample Unit
- Unit of Pavement Sampled 2004

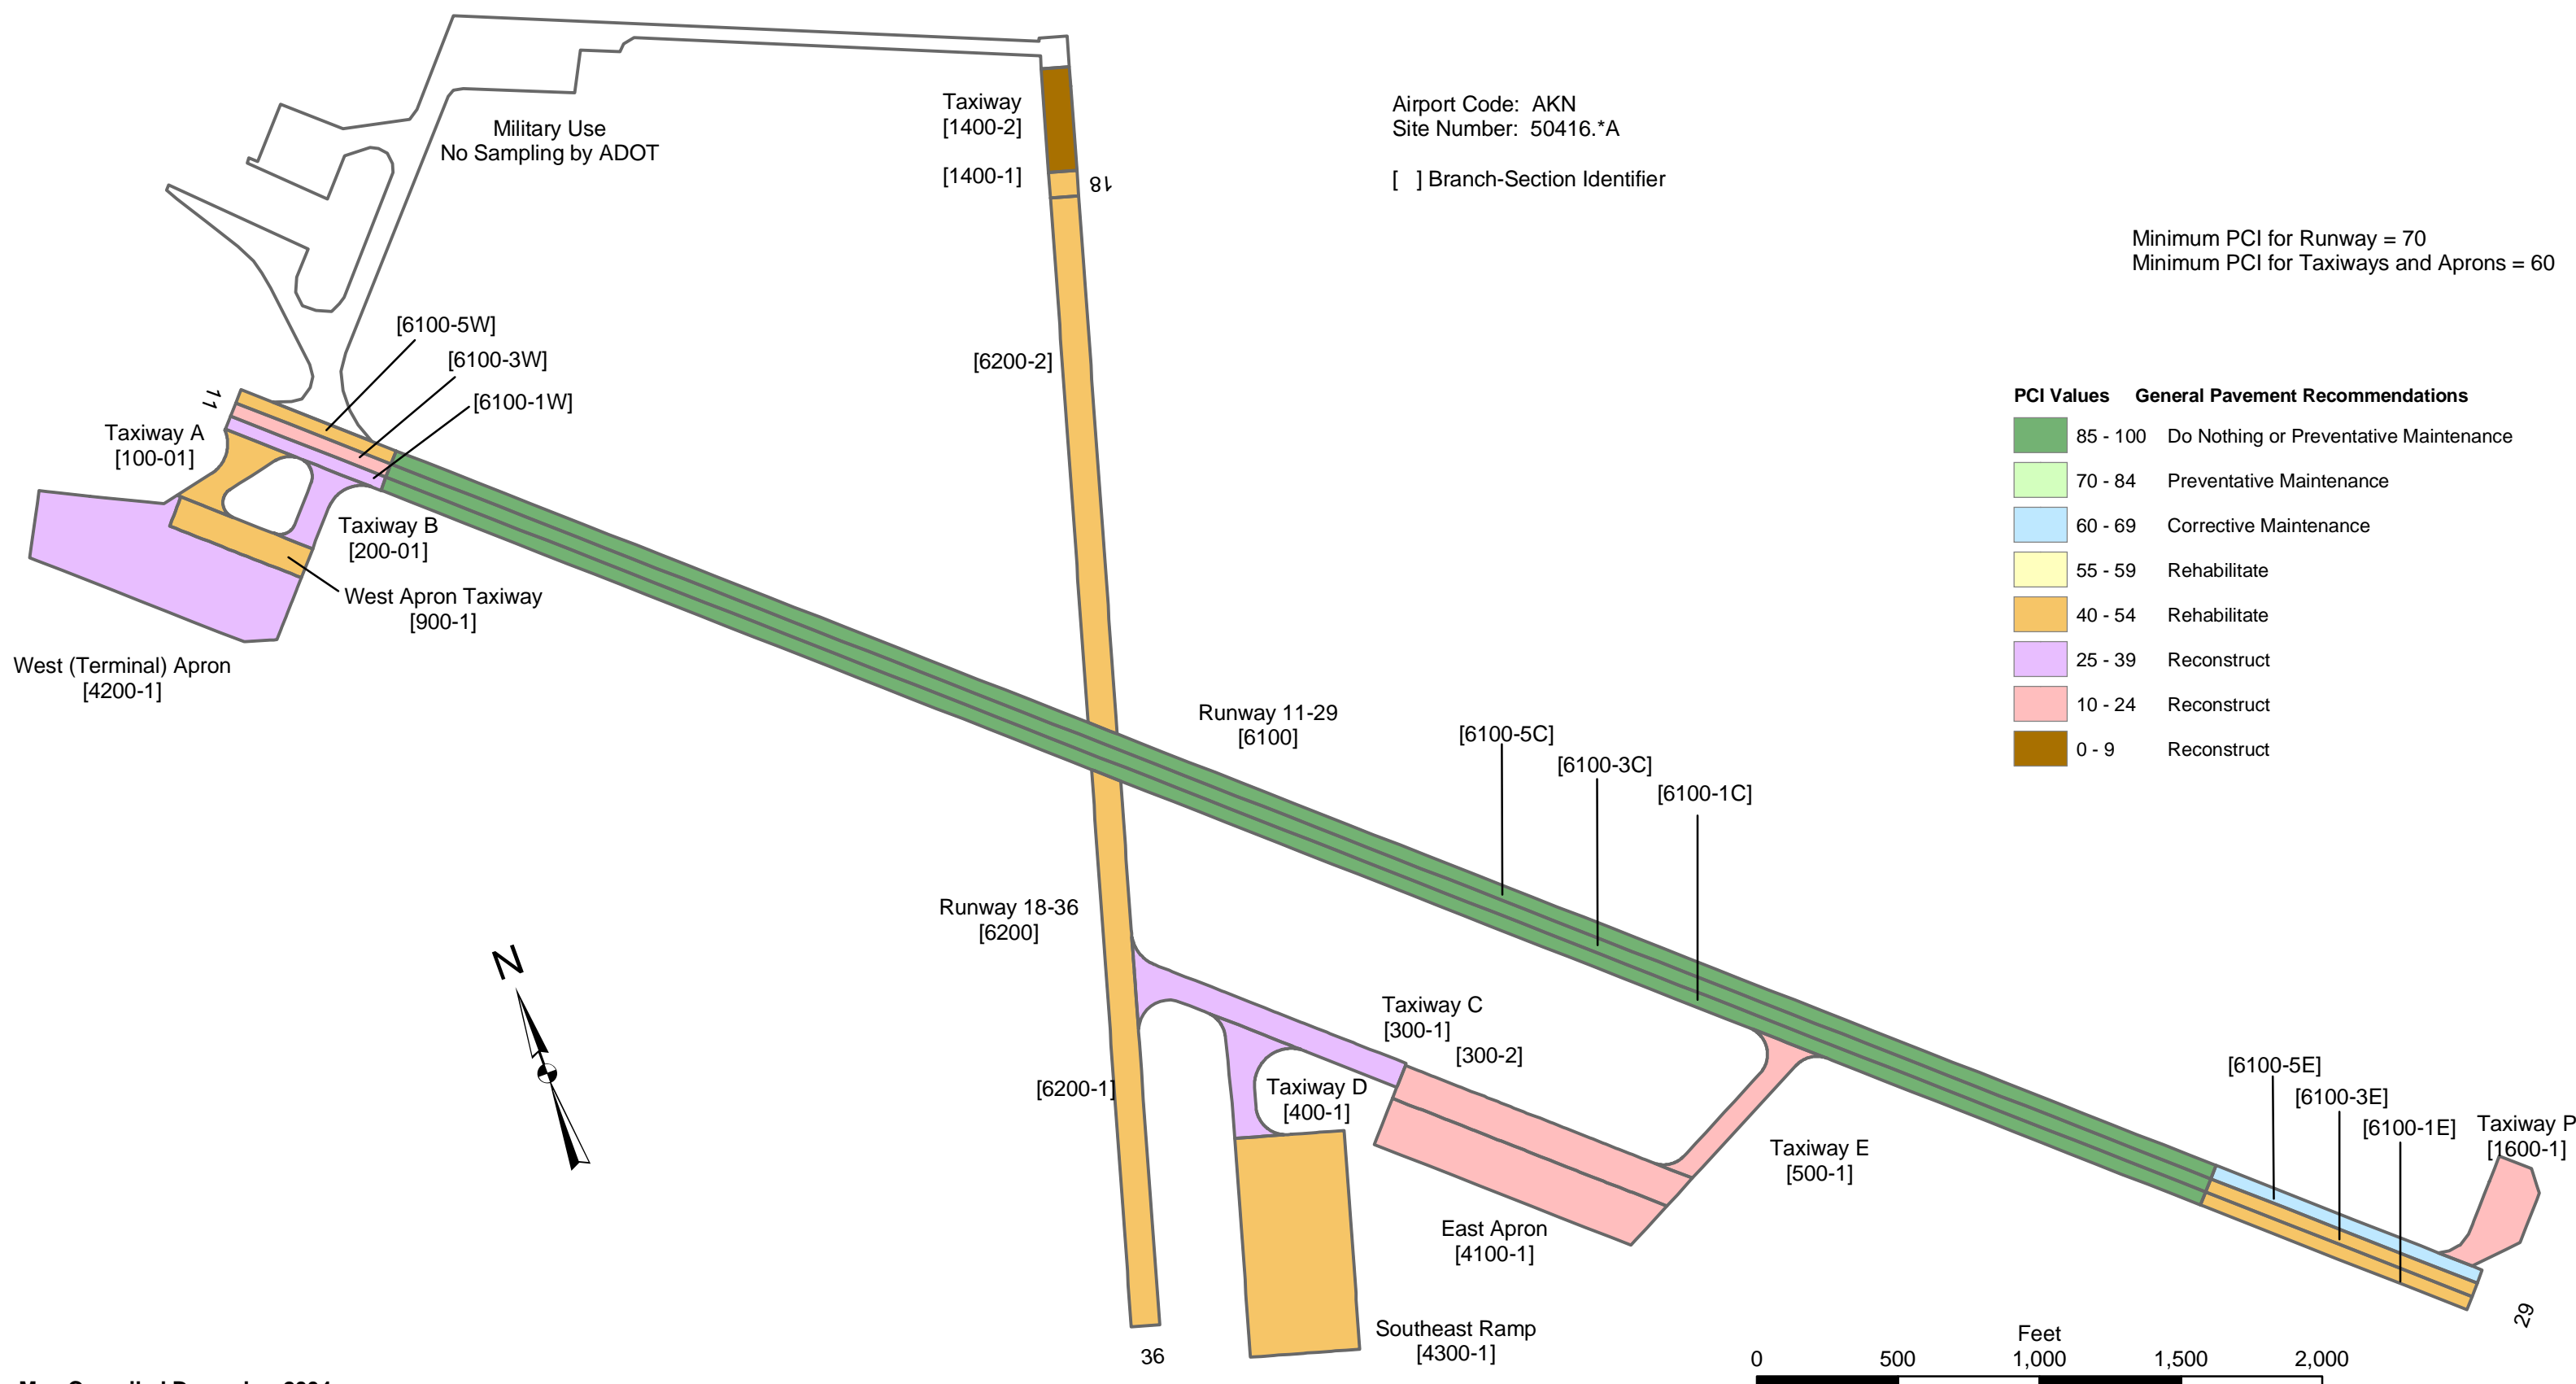
Pavement Condition Index (PCI) Measured Values for the Year 2004

- Next planned pavement condition survey: 2007
- 2004 reported pavement maintenance and/or changed conditions: Crack sealing done on the West Ramp, Taxiway A, Taxiway B and started on the Southeast Ramp. All ramps are in generally poor condition and of questionable strength. The over run for R/W 11 is also in poor condition. The Air Force has a project mostly designed for reconstruction and widening of T/W N.

- **Recommendations:** See PCI maps
